RAILWAY ACCIDENT

**Report on the Collision and
subsequent Derailment that
occurred on 26th July 1986
at Lockington Level Crossing**

IN THE
EASTERN REGION
OF BRITISH RAILWAYS

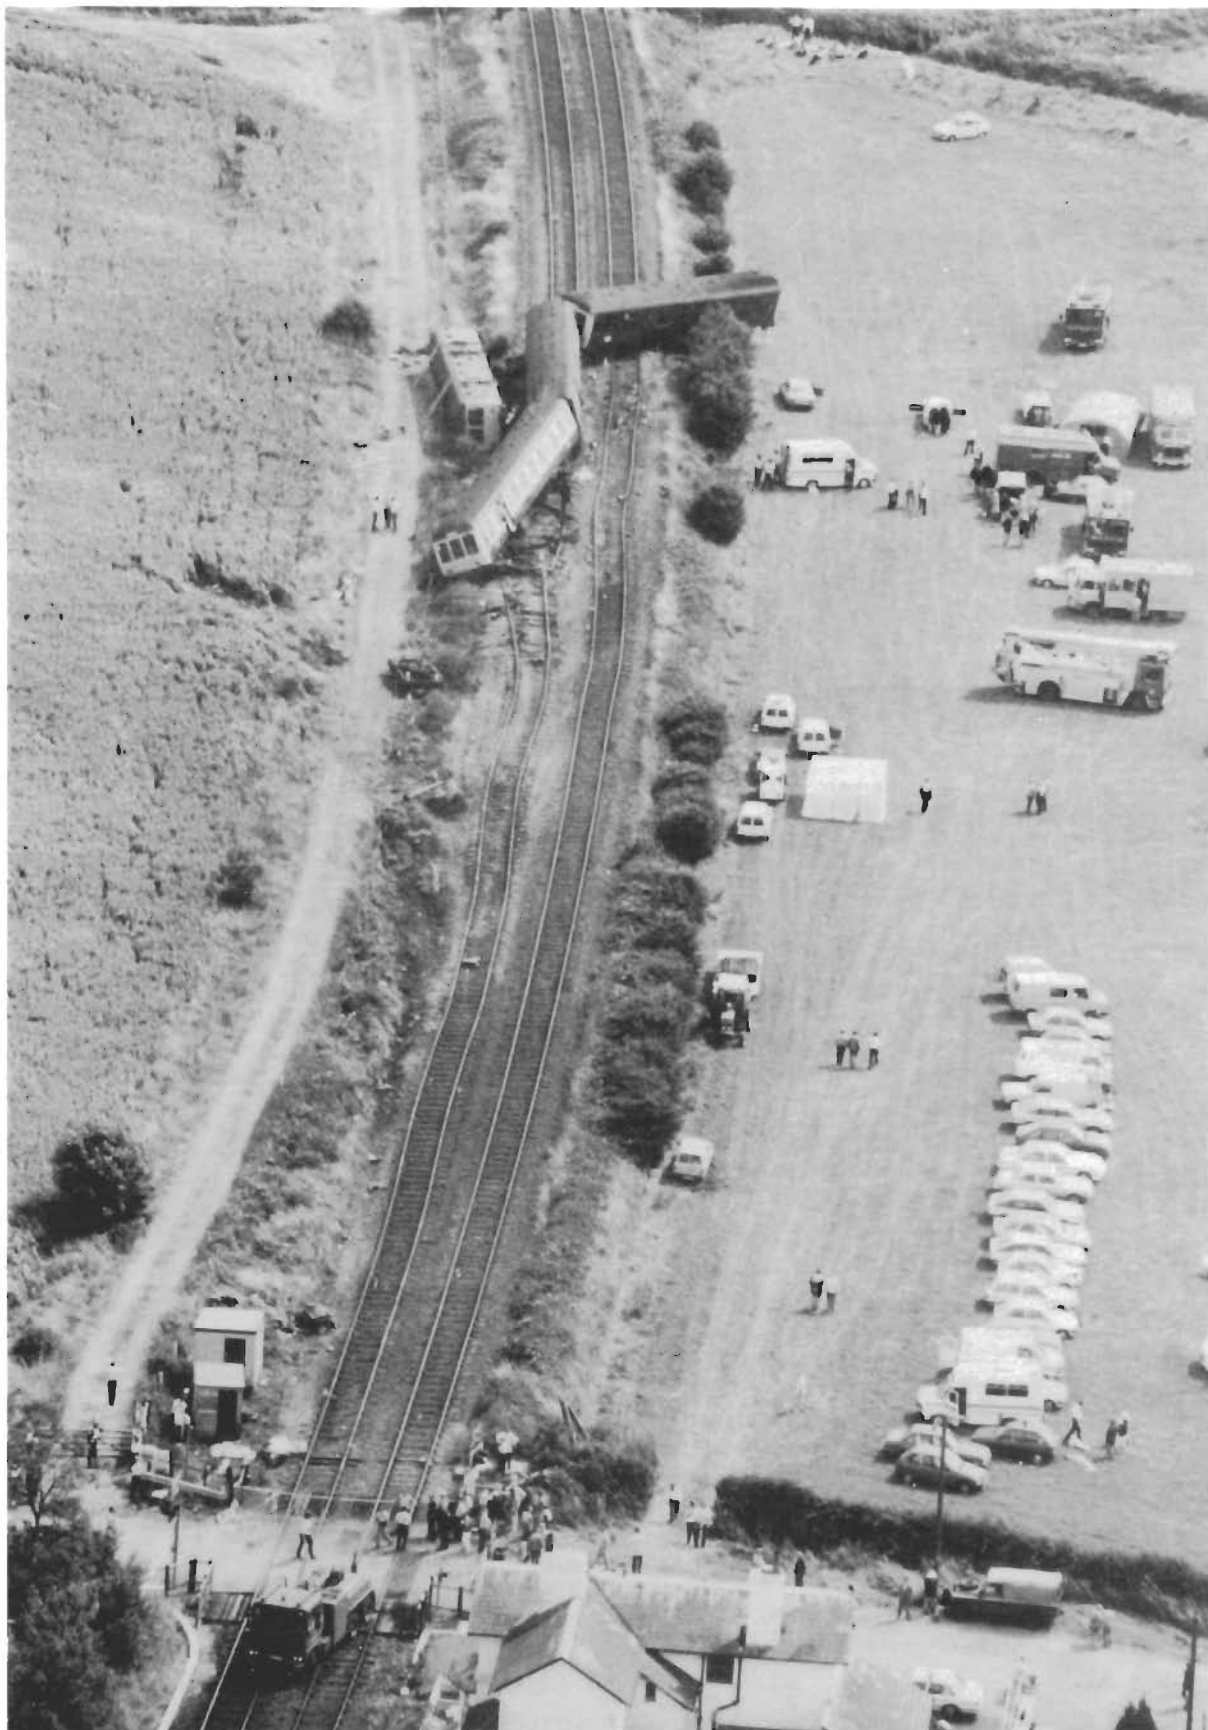
View looking south from crossing. Crossing equipment can be seen at bottom left-hand corner. Leading coach of train is on its side separated from other coaches and facing back towards Bridlington.

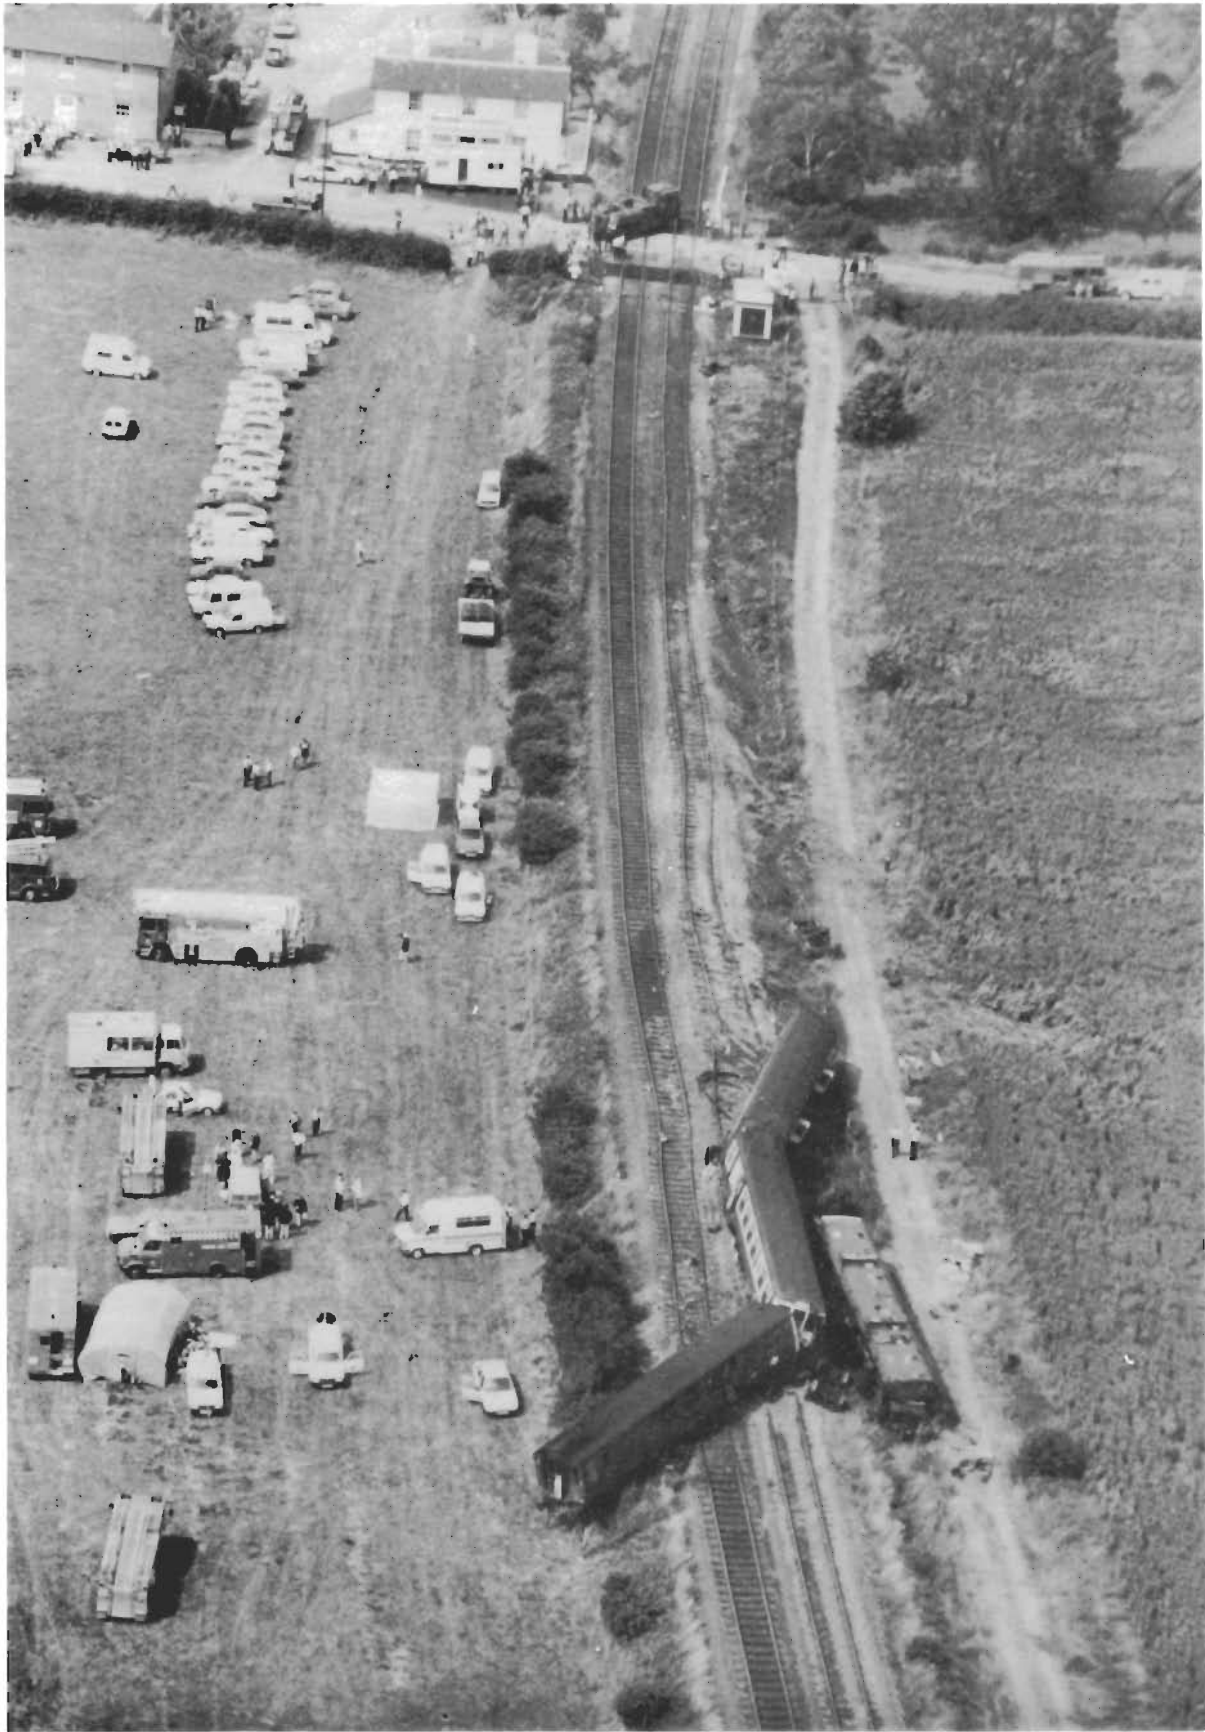
View looking north towards crossing. Exit from which Mr Ashley drove the van is between the white station house and the adjacent house and is occupied by a Fire Brigade vehicle. At the time of the accident the forecourt of the station house was unoccupied.
